**DEPARTMENT OF TRANSPORTATION****DIVISION OF ENGINEERING SERVICES**

Office of Structural Materials

Contract #: 04-0120F4Cty: SF/ALA Rte: 80 PM: 13.2/13.9File #: 69.15**SOURCE INSPECTION REPORT****Resident Engineer:**Pursell, Gary**Address:** 333 Burma Road**City:** Oakland, CA 94607**Report No:** SIR-002444**Date Inspected:** 25-Jun-2010**Project Name:** SAS Superstructure**OSM Arrival Time:** 700**Prime Contractor:** American Bridge/Fluor Enterprises, a JV**OSM Departure Time:** 1900**Contractor:** Zhenhua Port Machinery Company, Ltd (ZPMC), Changxing Island **Location:** Shanghai, China**Quality Control Contact:** Mr. Don Walton**Quality Control Present:** Yes No**Material transfer:** Yes No N/A**Sampled Items:** Yes No N/A**Stock Transfer:** Yes No N/A**OK to Cut:** Yes No N/A**Rebar Test Witness:** Yes No N/A**Delayed/Cancelled:** Yes No N/A**Other:** Coating Inspection**Bridge No:** 34-0006**Component:** See Below**Bid Item:** 77, 78, 79**Lot No:** B #204**Summary of Items Observed:**

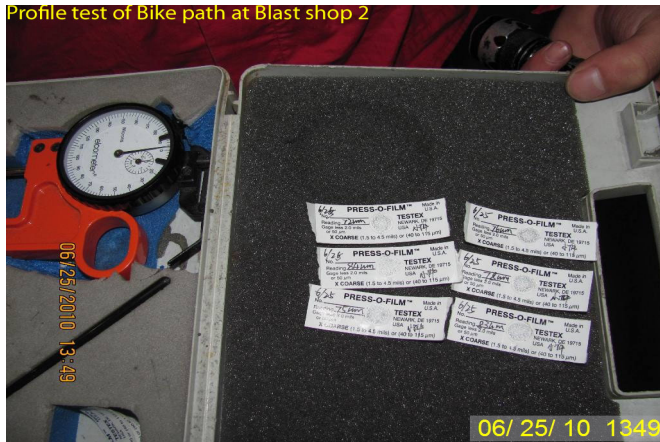
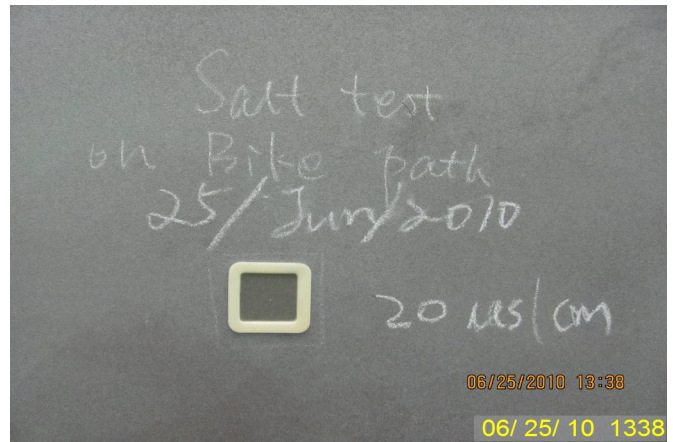
2. An inspection was requested for the Traveler Rail Brackets- 9 sets, Splices, Vortex plate splices, Bike path 2 sets -BK 001-035, 036, Bike path splices -12 pieces and 4 sets of suspender Brackets (SB58W, SB64W, SB68W, SB66E) for Surface preparation inspection, vide notification no. 3459 at Blasting shop 1 . This Caltrans inspector observed, ABF inspectors Mr. Sun, Mr. Shi Stone, Mr. Turtle and Mr.Vince performing said inspection check . The same was found accepted by ABF Inspectors after minor reblasting and Grinding in some of the marked places. The surface profile found to be in the range of 72 to 84 microns, and the salt test result found to be 20us/cm which is acceptable as per contract documents. The ambient conditions were monitored and is 3.4 deg. above dew

point and the relative humidity found to be 76.6% which is acceptable as per contract documents. International protective coatings technical service representative was not found present during the course of this inspection process. (Photograph showing Salt test and profile test results is attached)

Profile test of Bike path at Blast shop 2

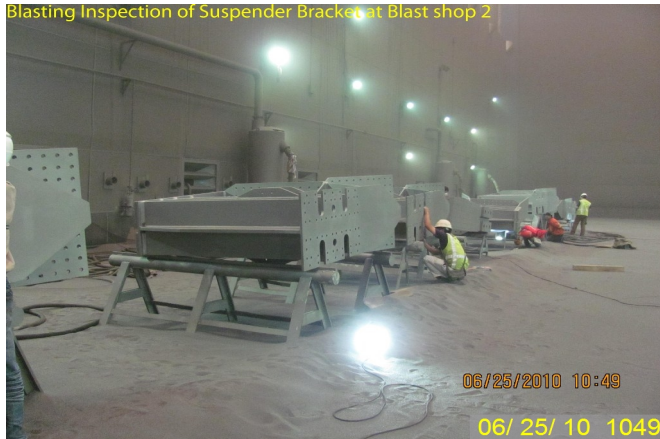
1. An inspection was requested on the OBG Suspender Bracket- 9 sets- SB50E, SB52E, SB52W, SB54E, SB56W, SB62E, SB64E, SB68E and SB 70E for surface preparation inspection, vide request no. 3458 at Blasting shop 2. This Caltrans inspector observed, ABF inspectors Mr. Sun , Mr. Turtle and Mr. Yui performing said inspection check . It was observed that, these surfaces were accepted by ABF Inspectors after minor reblast and after attending some Grinding points. The surface profile found to be in the range of 72 to 77 microns. The ambient conditions were monitored and is 3.6 deg. above dew point and the relative humidity found to be 79.4% which is acceptable as per contract documents. International protective coatings technical service representative was not found present during the course of this inspection process. (Photograph attached)

Blasting Inspection of Suspender Bracket at Blast shop 2
